EVALUATION OF VISCOTAQ® PIPELINE WRAP PERFORMANCE RELATED TO CRUDE OIL EXPOSURE

Final Report

2016-EERC-05-09

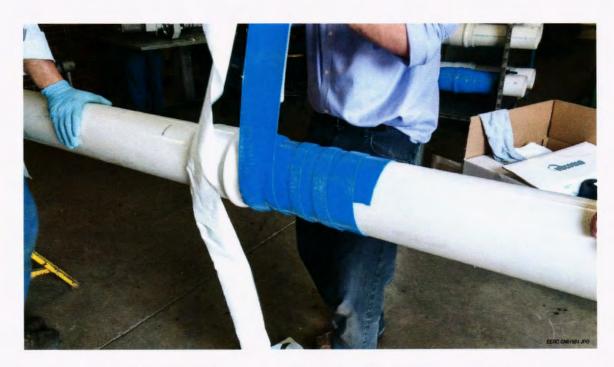
Figure 1. VISCOTAQ wrap being applied by Chuck Holt on June 2, 2015.

Before inserting the pipes into the test apparatus, Chuck Holt, a representative from Pro-Kote Engineering and Supply, arrived at the EERC in early June to wrap four of the six pipes with the VISCOTAQ bell and spigot sealing system (Figure 1). Three of these were single-wrapped and one was double-wrapped. Once wrapped, the pipes were inserted in the box with the ends extending beyond the walls of the test apparatus, and each was fitted with a pressure gauge and valves for venting and sampling. Once the pipes were inserted, the box was reinforced and tested for leaks by filling it with water. The pipes were also flushed with water and tested for leaks. After the leak checks were completed, the pipes were flushed several times with tap water followed by distilled water and tested for total organic carbon (TOC) until levels were at background levels (<1 mg/L). They were then filled with distilled water. The water pressure in Pipes 1, 2, 4, and 5 was maintained at 45 to 47 psi, while there was no internal pressure in Pipes 3 and 6 (Figure 2). Each pipe contained approximately 21 liters of water. Below are descriptions of the six test pipes:

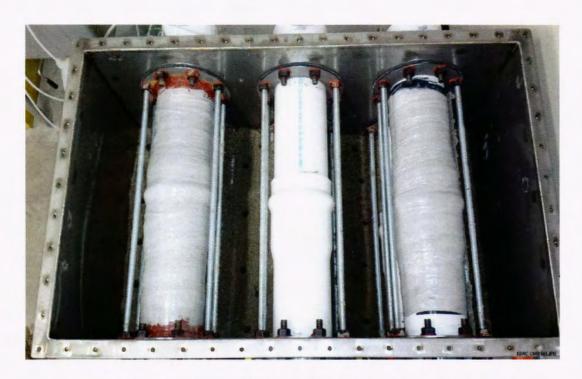
Figure 3. Top view of box after the first layer of sand was added.

On June 11, 2015, the box was filled with a mixture of damp sand and Bakken crude oil. The sand and oil were added in layers by filling the box approximately one-third full with sand (Figure 3) and then pouring 20 gallons (four 5-gallon pails) of crude slowly over the sand, which was readily absorbed. This was followed by another layer of sand and 20 gallons of oil and then a final layer of sand and 15 gallons of oil (Figures 4 and 5). This resulted in a completely saturated sand—oil mixture (Figure 6). The test box was covered with a stainless steel plate lined with a Viton® gasket and bolted along the edges. A pressure release valve was installed in the center of the top cover, with a pipe vent to an exhaust fan.

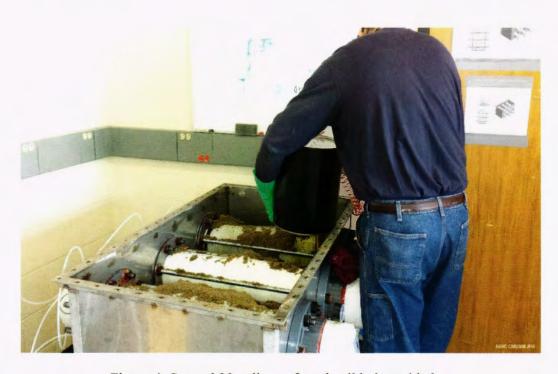
Figure 4. Second 20 gallons of crude oil being added.

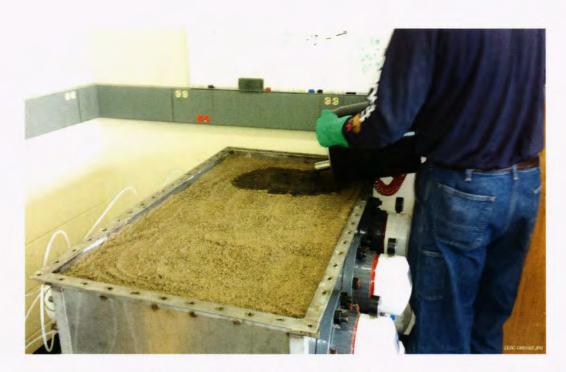
Figure 5. Final addition of crude oil.

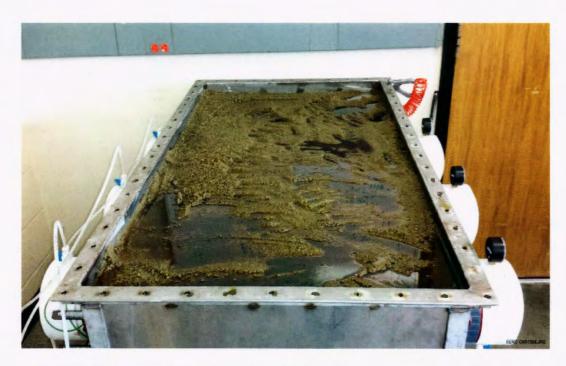
Figure 6. View of the fully saturated sand before the top cover was applied.

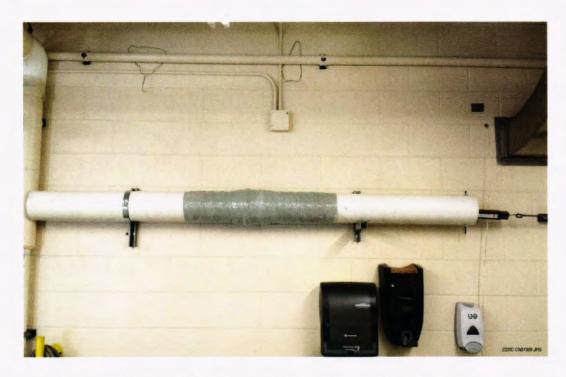
Figure 7. Wall-mounted pipe used for tension testing.

One additional test was performed to evaluate the cohesiveness of the VISCOTAQ sealing system when used on rural water supply pipes that may be subject to expansive and compressive stress conditions as a result of seasonal temperature fluctuations in the subsurface. A jointed section of PVC pipe was wrapped with the VISCOTAQ sealing system, and an initial tension of 30 psi was applied to one end of the pipe, while the other end was fixed to a stable bracket (Figure 7). A spring gauge was used to monitor the tension on the pipe, and the gauge was checked regularly for the duration of the project. The tension remained at 30 psi, and no visible changes to the pipe or the VISCOTAQ pipe wrap were detected.
